WASTE WATER TREATMENT PLANT
AL KASIK MILITARY TRAINING BASE
AL KASIK, IRAQ

SIGIR PA-06-074
JANUARY 29, 2007

SUBJECT: Report on Waste Water Treatment Plant, Al Kasik Military Training Base, Al Kasik, Iraq (Report Number SIGIR PA-06-074)

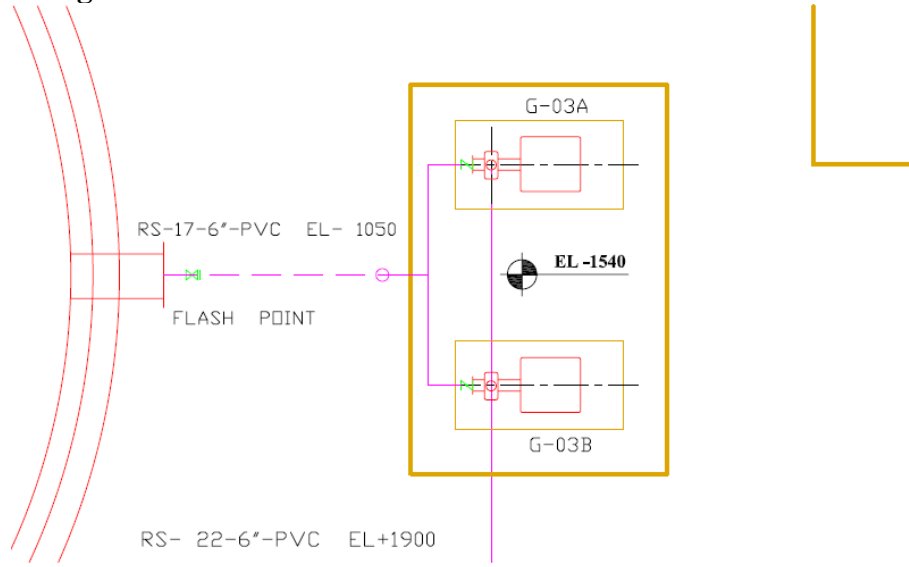
Diagram 3. Pump Station G-03 from contractor's piping plan drawing.

The G-03 pump station located beside the D-07 tank consisted of a below grade reinforced concrete pad with foundation walls. Placing the pumps below grade improved the efficiency of the pumps located on pads identified as G-03A and G-03B in Diagram 3. In addition, the diagram shows the relative location of the pump station in relation to the edge of the D-7 tank. In comparison to many of the concrete structures observed throughout the WWTP, the G-03 pump station was not a large structure. It measured approximately, 4.4 m (14.5 ft) by 2.7 m (9 ft) by 1.7 m (5.6 ft) deep. During the site visit, the assessment team observed significant fractures in the concrete structure along the base, walls, and corners of the G-03 pump station. A series of photos (Site Photos 11-18) illustrate what the assessment team observed while on site. Site Photos 11-16 were taken from inside the pump station while Site Photos 17 and 18 were taken from the outside.

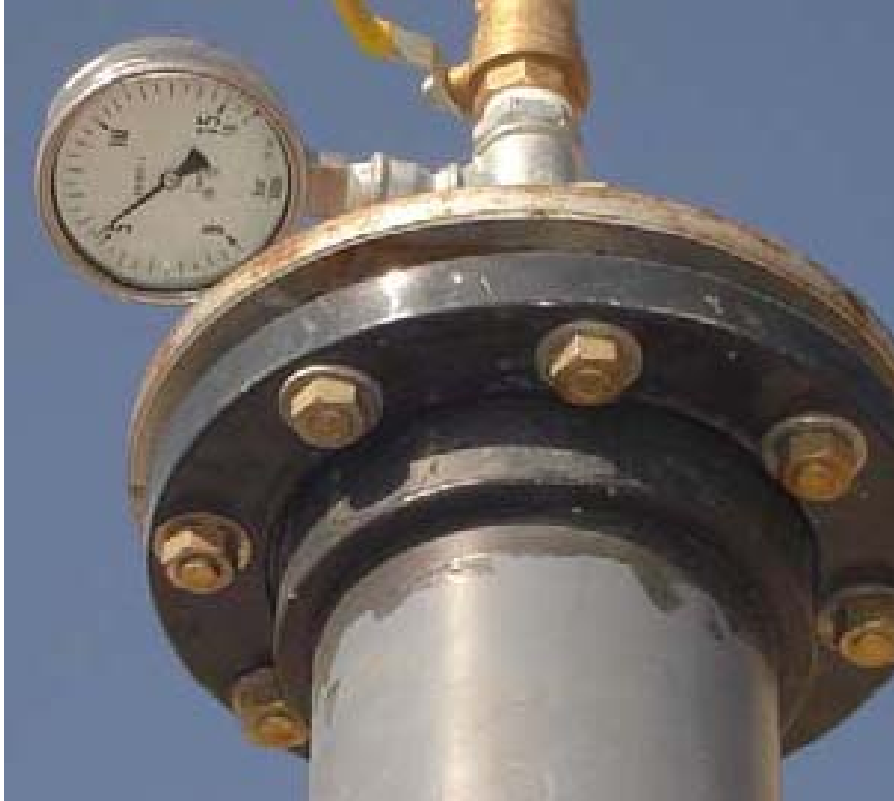
QA Photo 1. Pressure testing a pipeline (from QA Report 4 Oct 2005).

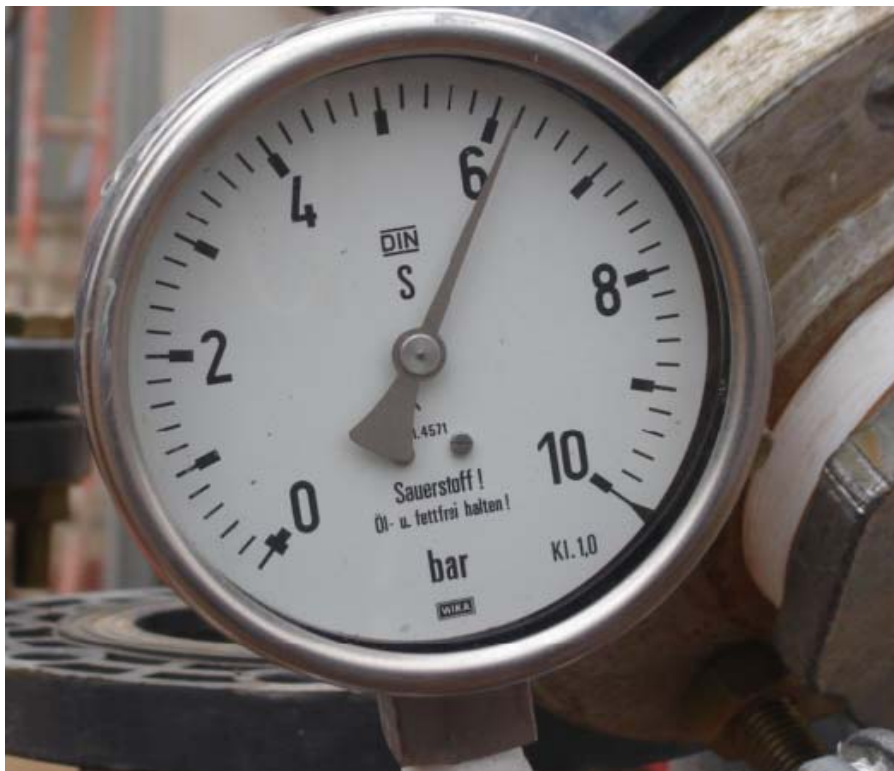
QA Photo 2. Hydro-testing a pipe line between tanks (from QA Report 23 Dec 2005).

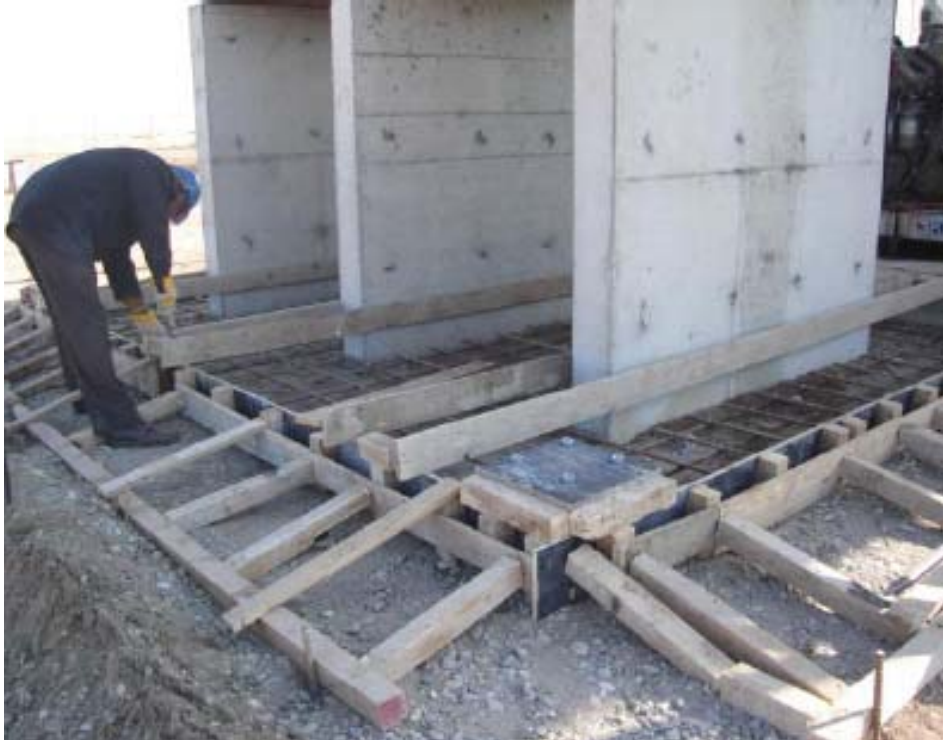
QA Photo 5. Flatwork form with clear / sufficiently sized lumber and proper brace placement (from QA Report 14 Dec 2005).

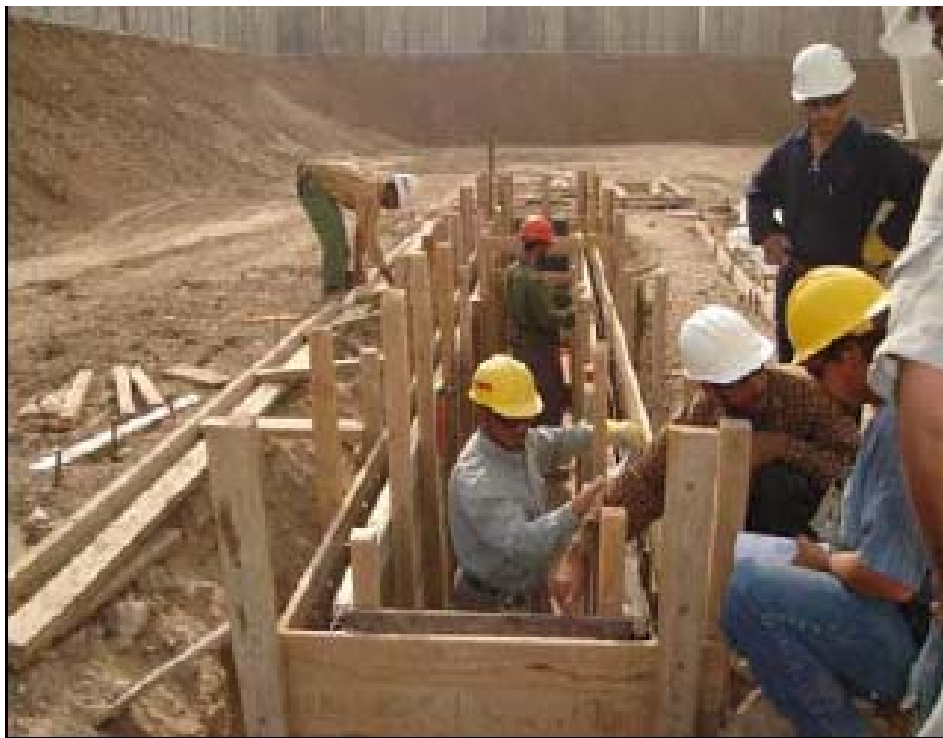
QA Photo 6. Good form techniques were used to build a sub-grade foundation with supervisors on site (from QA Report 11 Oct 2005).

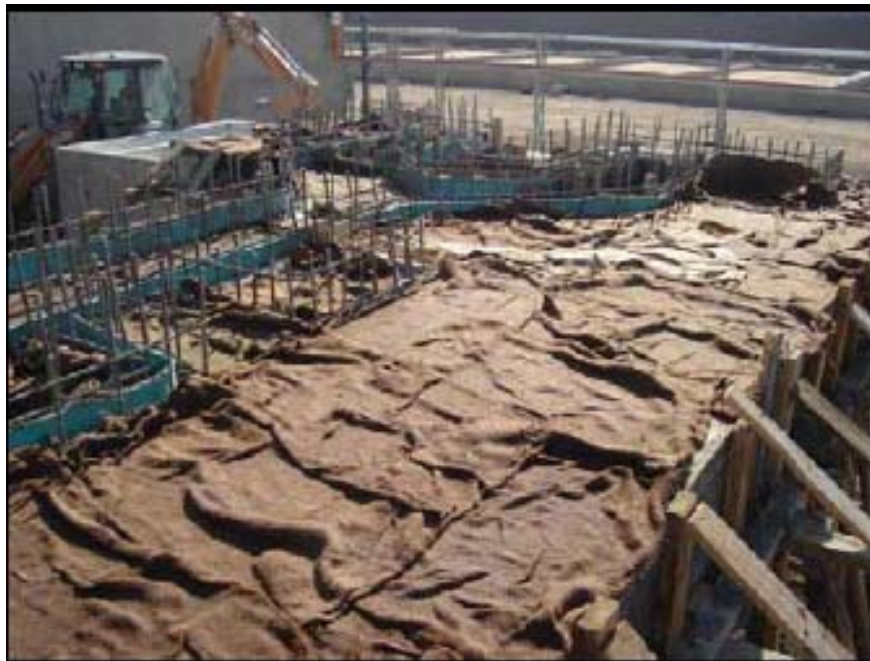
QA Photo 8. Concrete covered with burlap to prevent too rapid drying and decreased strength (from QA Report 3 Oct 2005).

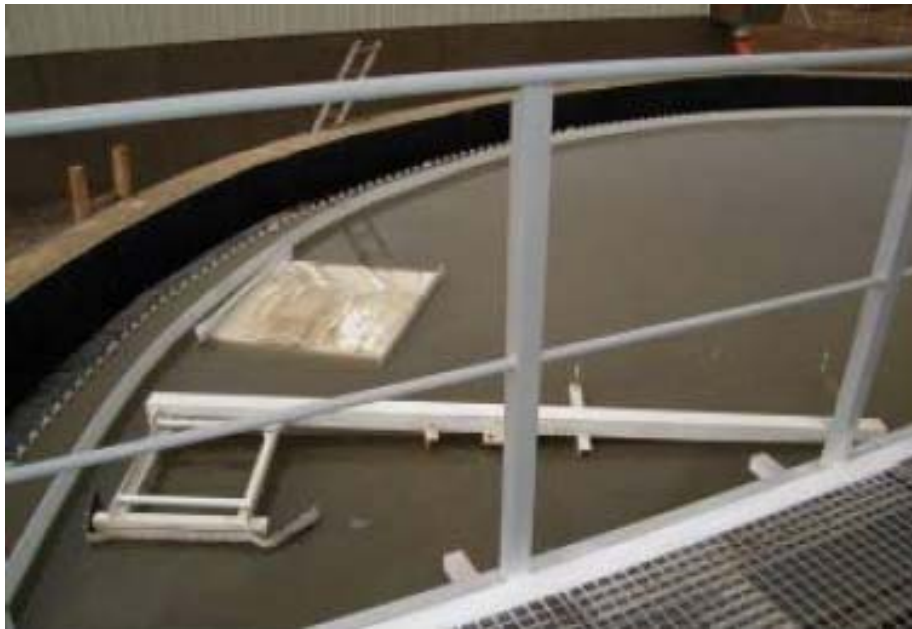
QA Photo 10. Full clarifier tank (from QA Report dated 5 Feb 2006)
